PROPERTY CONDITION ASSESSMENT REPORT

**2-STORY OFFICE BUILDING
2210 ENTERPRISE DRIVE
FLORENCE, SOUTH CAROLINA**

PROJECT NO.: 10135-K

DECEMBER 15, 2017

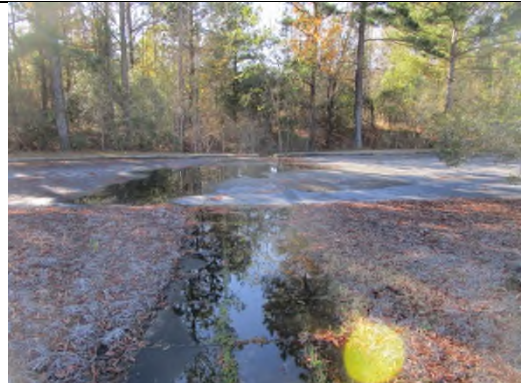
Condition: Some evidence of minor water ponding conditions was observed within the south and east parking lots and perimeter drive. The ponding appeared to be localized with minimal depths (less than ½-inch) of water collected. CC&I recommends that consideration be given to either installing flumes across the landscape strip or modifying grades within the perimeter drive at the south side of the site to improve site drainage conditions. No significant issues were noted.

Photo 8: View of poor drainage conditions at south perimeter drive

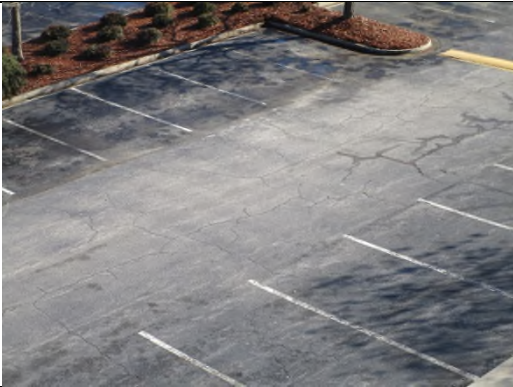
Condition: The asphalt pavements are worn with cracks evident of the pavement age throughout. Some vegetation was observed growing in some of the cracks. Striping throughout the parking lots is faded. The last application of a seal coat and restriping was reported to have occurred in 2008. Cleaning and filling of the asphalt cracks, sealcoating, and re-striping of the parking lot and all of the drives is recommended at this time and included as part of future maintenance. No repairs or replacement appears to be warranted immediately. No significant issues were noted or reported

Photo 9: View of cracks in parking lot asphalt pavements (typical)

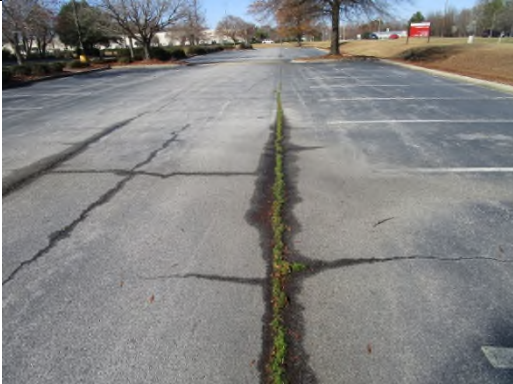
Photo 11: View of vegetation in asphalt cracks in west parking lot

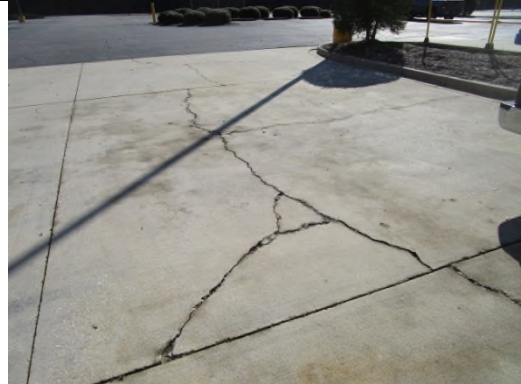
Photo 12: View of cracks in concrete loading dock pavements

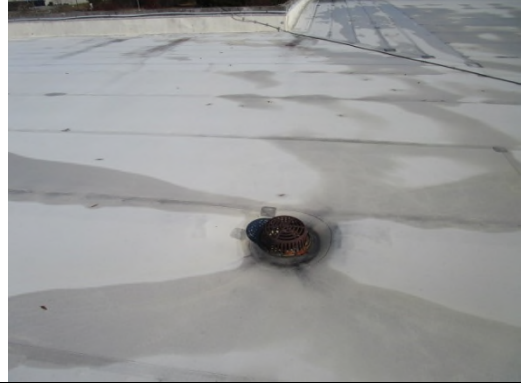
- There is evidence of minor debris accumulation at the interior roof drains and at the northeast corner of the roof. This debris should be cleaned from the roof.
- Some of the mechanical fasteners for the insulation has begun to back out and are evident beneath the roofing membrane. Further raising of the fasteners could result in punctures to the membrane.
- Cracking and crazing of the roofing membrane was observed at various locations. This condition is typically the result of plasticizer migration from the PVC as it ages.
- The metal decking over the rear patio area has begun to rust at the gutter along the east side of the roof. Painting/sealing of the metal decking is recommended.
- No evidence of recent or on-going roof leaks due to this condition was observed or reported.

Photo 20: View of debris at roof drain

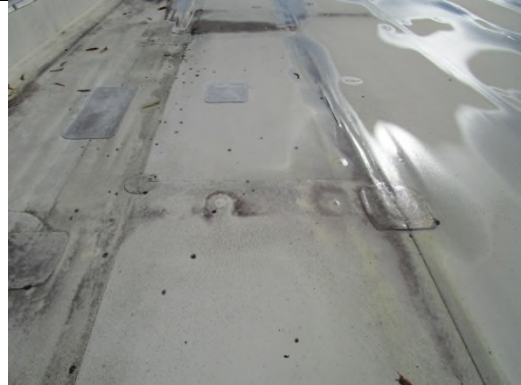
Photo 22: View of mechanical fasteners backing out (raising)

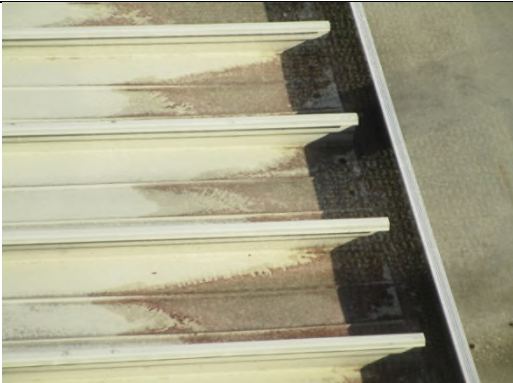
Photo 23: View of rusted metal roofing over patio on east side of building

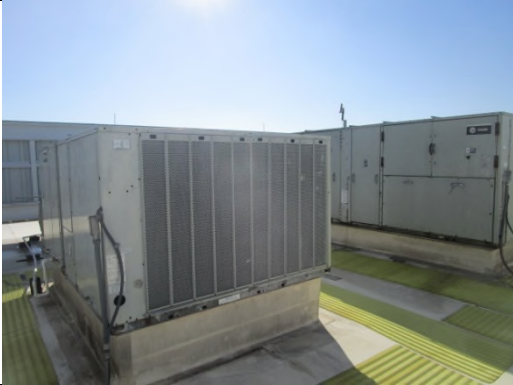
- Compressors have recently been replaced on two of the RTUs.
- RTU 5's electrical control panel makes a continuous clicking noise and reportedly doesn't cycle off properly. Repair of this condition is recommended.
- Nine of the RTUs have reached their anticipated service life of 20 years. Budgeting for the replacement of the older RTUs (total of 457 ½ tons) in the next 3 to 5 years is recommended.

Photo 25: View of RTUs

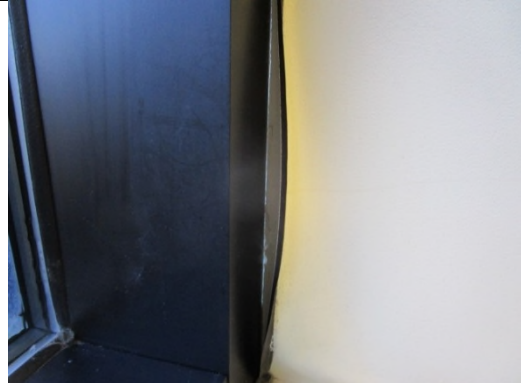
Condition: The interior walls within the northern open office areas on the ground floor which have not been up-fitted recently has peeling wall paper which will require removal and replacement. These areas are anticipated to be improved during the next tenant up-fits. No significant issues were noted.

Photo 38: View of peeling wallpaper in north office area on ground floor

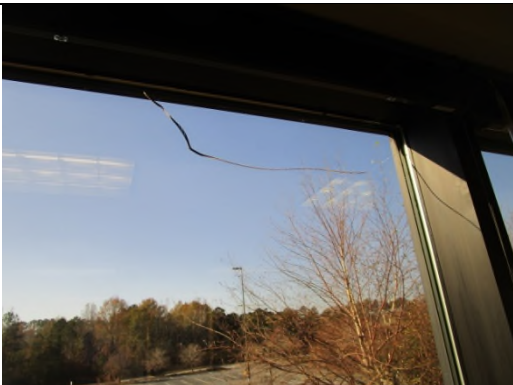
Condition: A single window on the second floor south wall of the building is cracked and should be replaced. Some spotting/staining from acid rain on some of the ground floor windows on the east and north sides of the building was observed. A commercial window washing contractor should be retained to remove these stains. No other significant issues were noted.

Photo 53: View of cracked window on south end of second floor of building

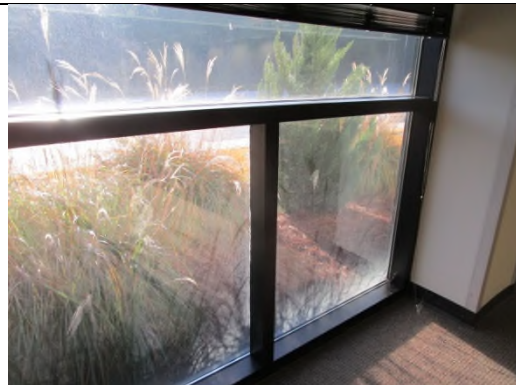
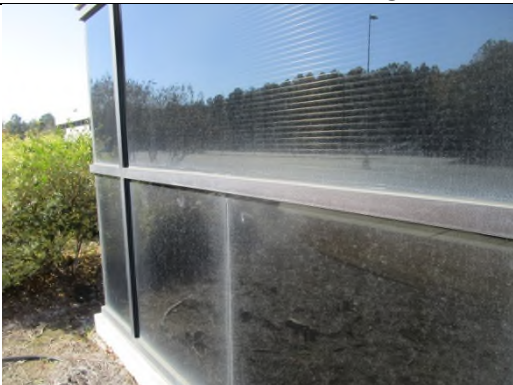
Photo 54: View of acid rain staining on ground floor windows at northeast corner of building

Photo 55: View of acid rain staining on ground floor windows at northeast corner of building
